# Tips For Improving AZL s F59PHI

In 2004, American Z Line released their first run of F59PHI locomotives and Bombardier passenger cars. This was followed in early 2005 with a second run of F59PHI sets with Bombardier cars and the all new Amtrak California and Amtrak West coaches. Since releasing these sets, owners have reported the need for a few minor modifications.

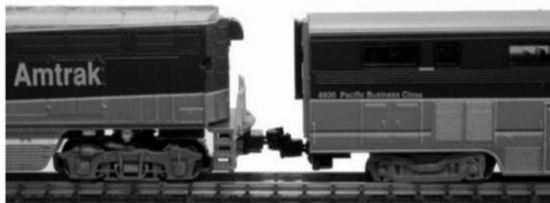
**Figure 1** shows the pegs that insert in the clip on the chassis and the pins that hold the rear porch in place.

**Out of the box**, this locomotive demonstrates the result of a improperly installed clip and raised DCC pocket.

The F59PHI locomotive is masterfully engineered. The construction does not include a single screw and simply clips together. The shell is solid, but two areas have been troublesome for clients. The rear porches and snow plow are held in place with extremely small plastic pins cast into the shell. These pins can break and loosen causing the rear porch and coupler to become a problem. There is an easy fix. It is recommended that a small drop of CA glue is applied to the pins. This will hold the plow and porch firmly in place and strengthen the pin assembly.

On inspection, AZL found that shells on some of the locomotives were sitting too high (above). We have found two reasons this occurs. The first reason is the mis-position of the top gray clip that holds the chassis together. This clip has two small holes that correspond to pegs cast into the shell (figure 1). The two holes should face towards the rear of the

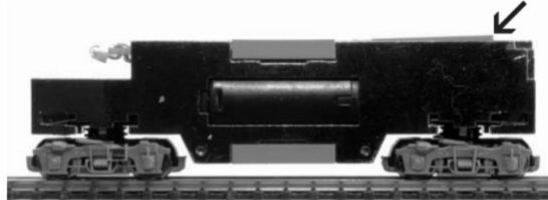
**Figure 3:** The raised DCC pocket (arrow). This should be filed flush with the chassis.

The second issue only affects the second run of F59PHIs. Strangely, this manufacturing issue did not occur on the first run. The DCC pocket on the second F59PHI run does not sit flush against the chassis on some locomotives. The rear of the pocket rises above the chassis. This causes the shell to lift and coupling becomes an issue. If this condition occurs, a file should be used to file away the plastic until it is flush with the metal chassis. Be careful that you remove all filings so they do not fall into the drive train.

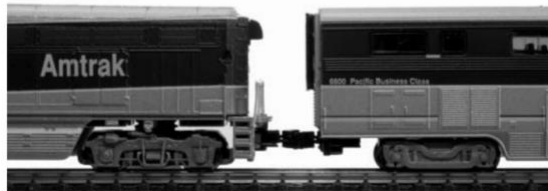
The clip alignment has been corrected and the DCC pocket has been filed down. The couplers now align correctly.
